Water Body
Site Investigation Report

SunE Westbrook
Solar Energy Project

prepared for
SunEdison

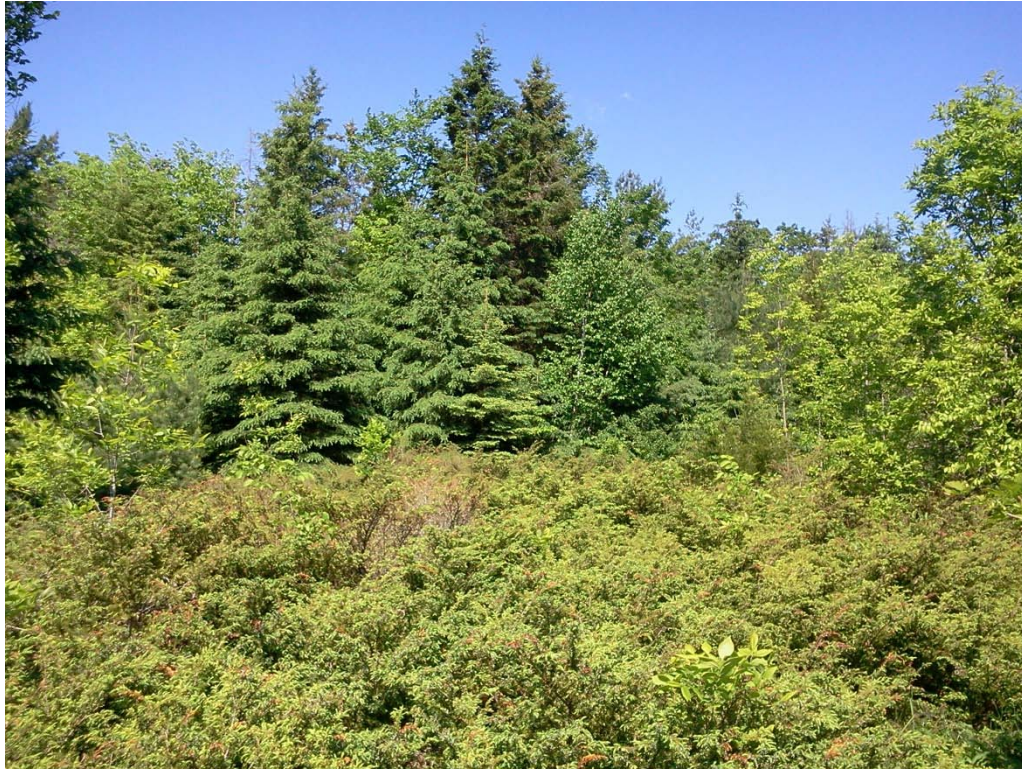
Figure 4.2 Typical upland shrub thicket communities within Westbrook Project Location.

The *Water Body Records Review Report* (Genivar, 2011) did not identify any permanent streams on or within 120 m of the Project Location. This was confirmed during a site investigation completed on June 18, 2010. Most of the site is represented by upland thicket and young woodland (Figure 4.2).

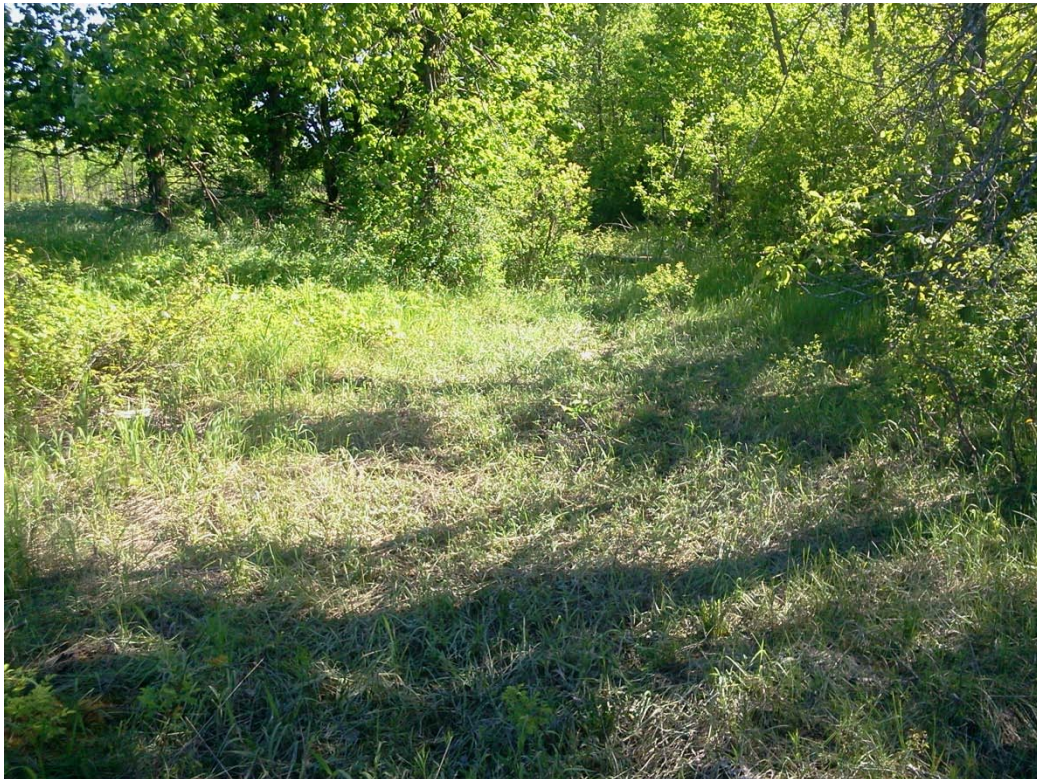
Figure 4.3 Grass swale associated with seasonally intermittent stream location (June, 2011)

The *Water Body Records Review Report* (Genivar, 2011) identified a single intermittent stream on and within 120 m of the Project Location to the southeast. This feature was confirmed and characterized during site investigations completed on April 6 and June 1, 2011 (Figures 4.3 and 4.4).

The stream is approximately 3 km in length and flows from a lowland forest to the northeast of the Project Location southwest to Glenvale Creek approximately 1.5 km to the south. Within 120 m of the Project Location, the creek channel is approximately 1-2 m in width and 20-30 cm deep at centre. Most of the creek is represented as a grass swale with no aquatic vegetation. There are sedges and rushes along portions of the creek, where soils are moist year-round. Flow was observed within the channel in mid spring, but was absent by June. The creek does not support fish or fish habitat; however, several amphibians (frogs) were noted within 30 m of the feature on April 6, 2011.

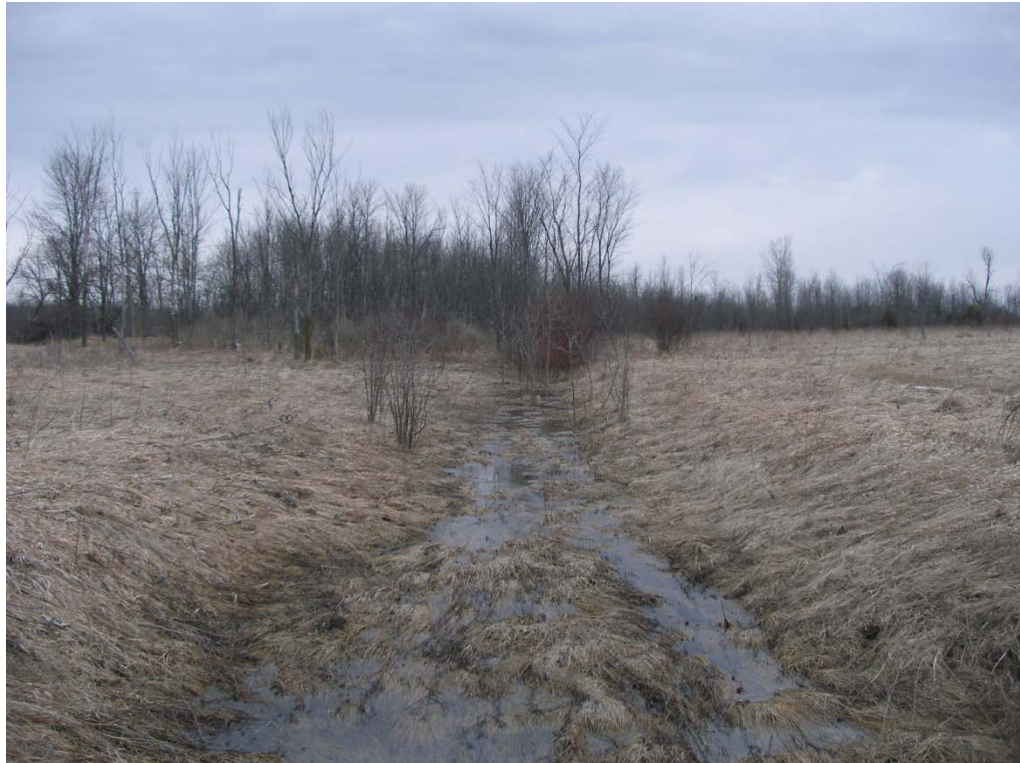
Figure 4.4. Seasonal drainage (April 6, 2011).

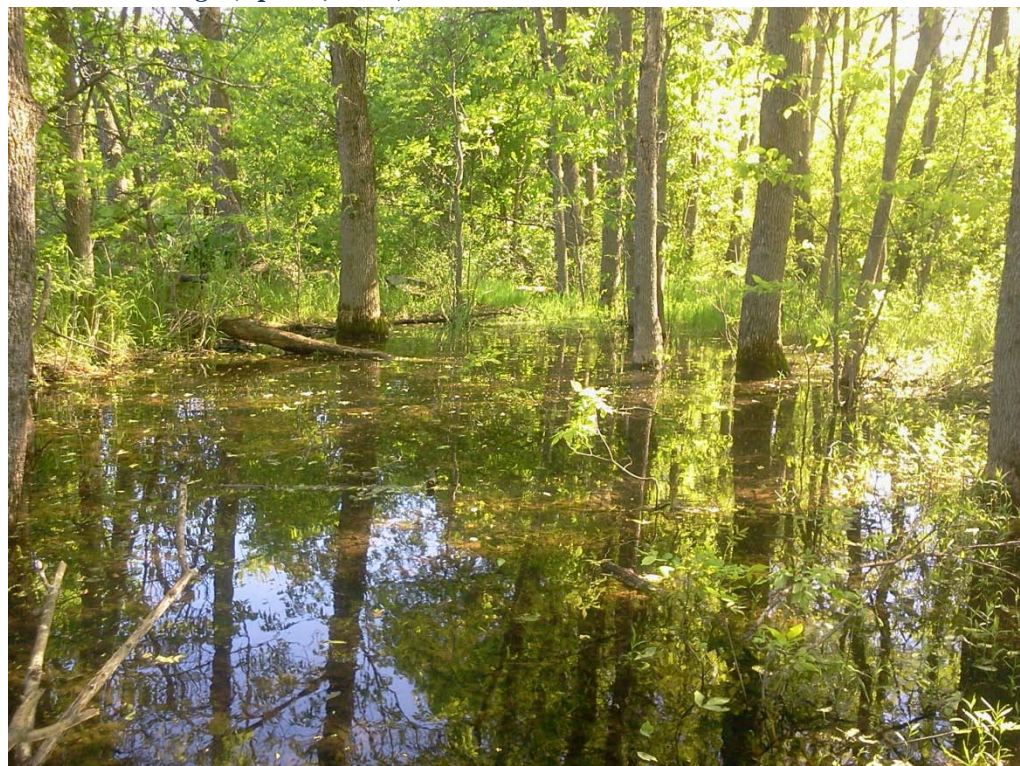
Figure 4.5. Vernal pool within maple swamp forest north of Project Location (June 1, 2011).

Other water features that were observed during the site investigation, but do not meet the definition of a water body as outlined in the REA Regulation were considered in this report for the Project Location and 120 m adjacent lands. Site investigations on June 1, 2011 identified small (<0.2 ha) vernal pools within a 9 ha swamp forest north of the Project Location (Figure 4.5). In the *EIS* report, it was determined that this wetland would not be impacted or encroached upon by the development (Ecological Services, 2011b).
