**Water Body
Site Investigation Report**

**Napanee TS Taylor Kidd
Solar Energy Project**

prepared for
Axio Power Canada Inc./SunEdison Canada

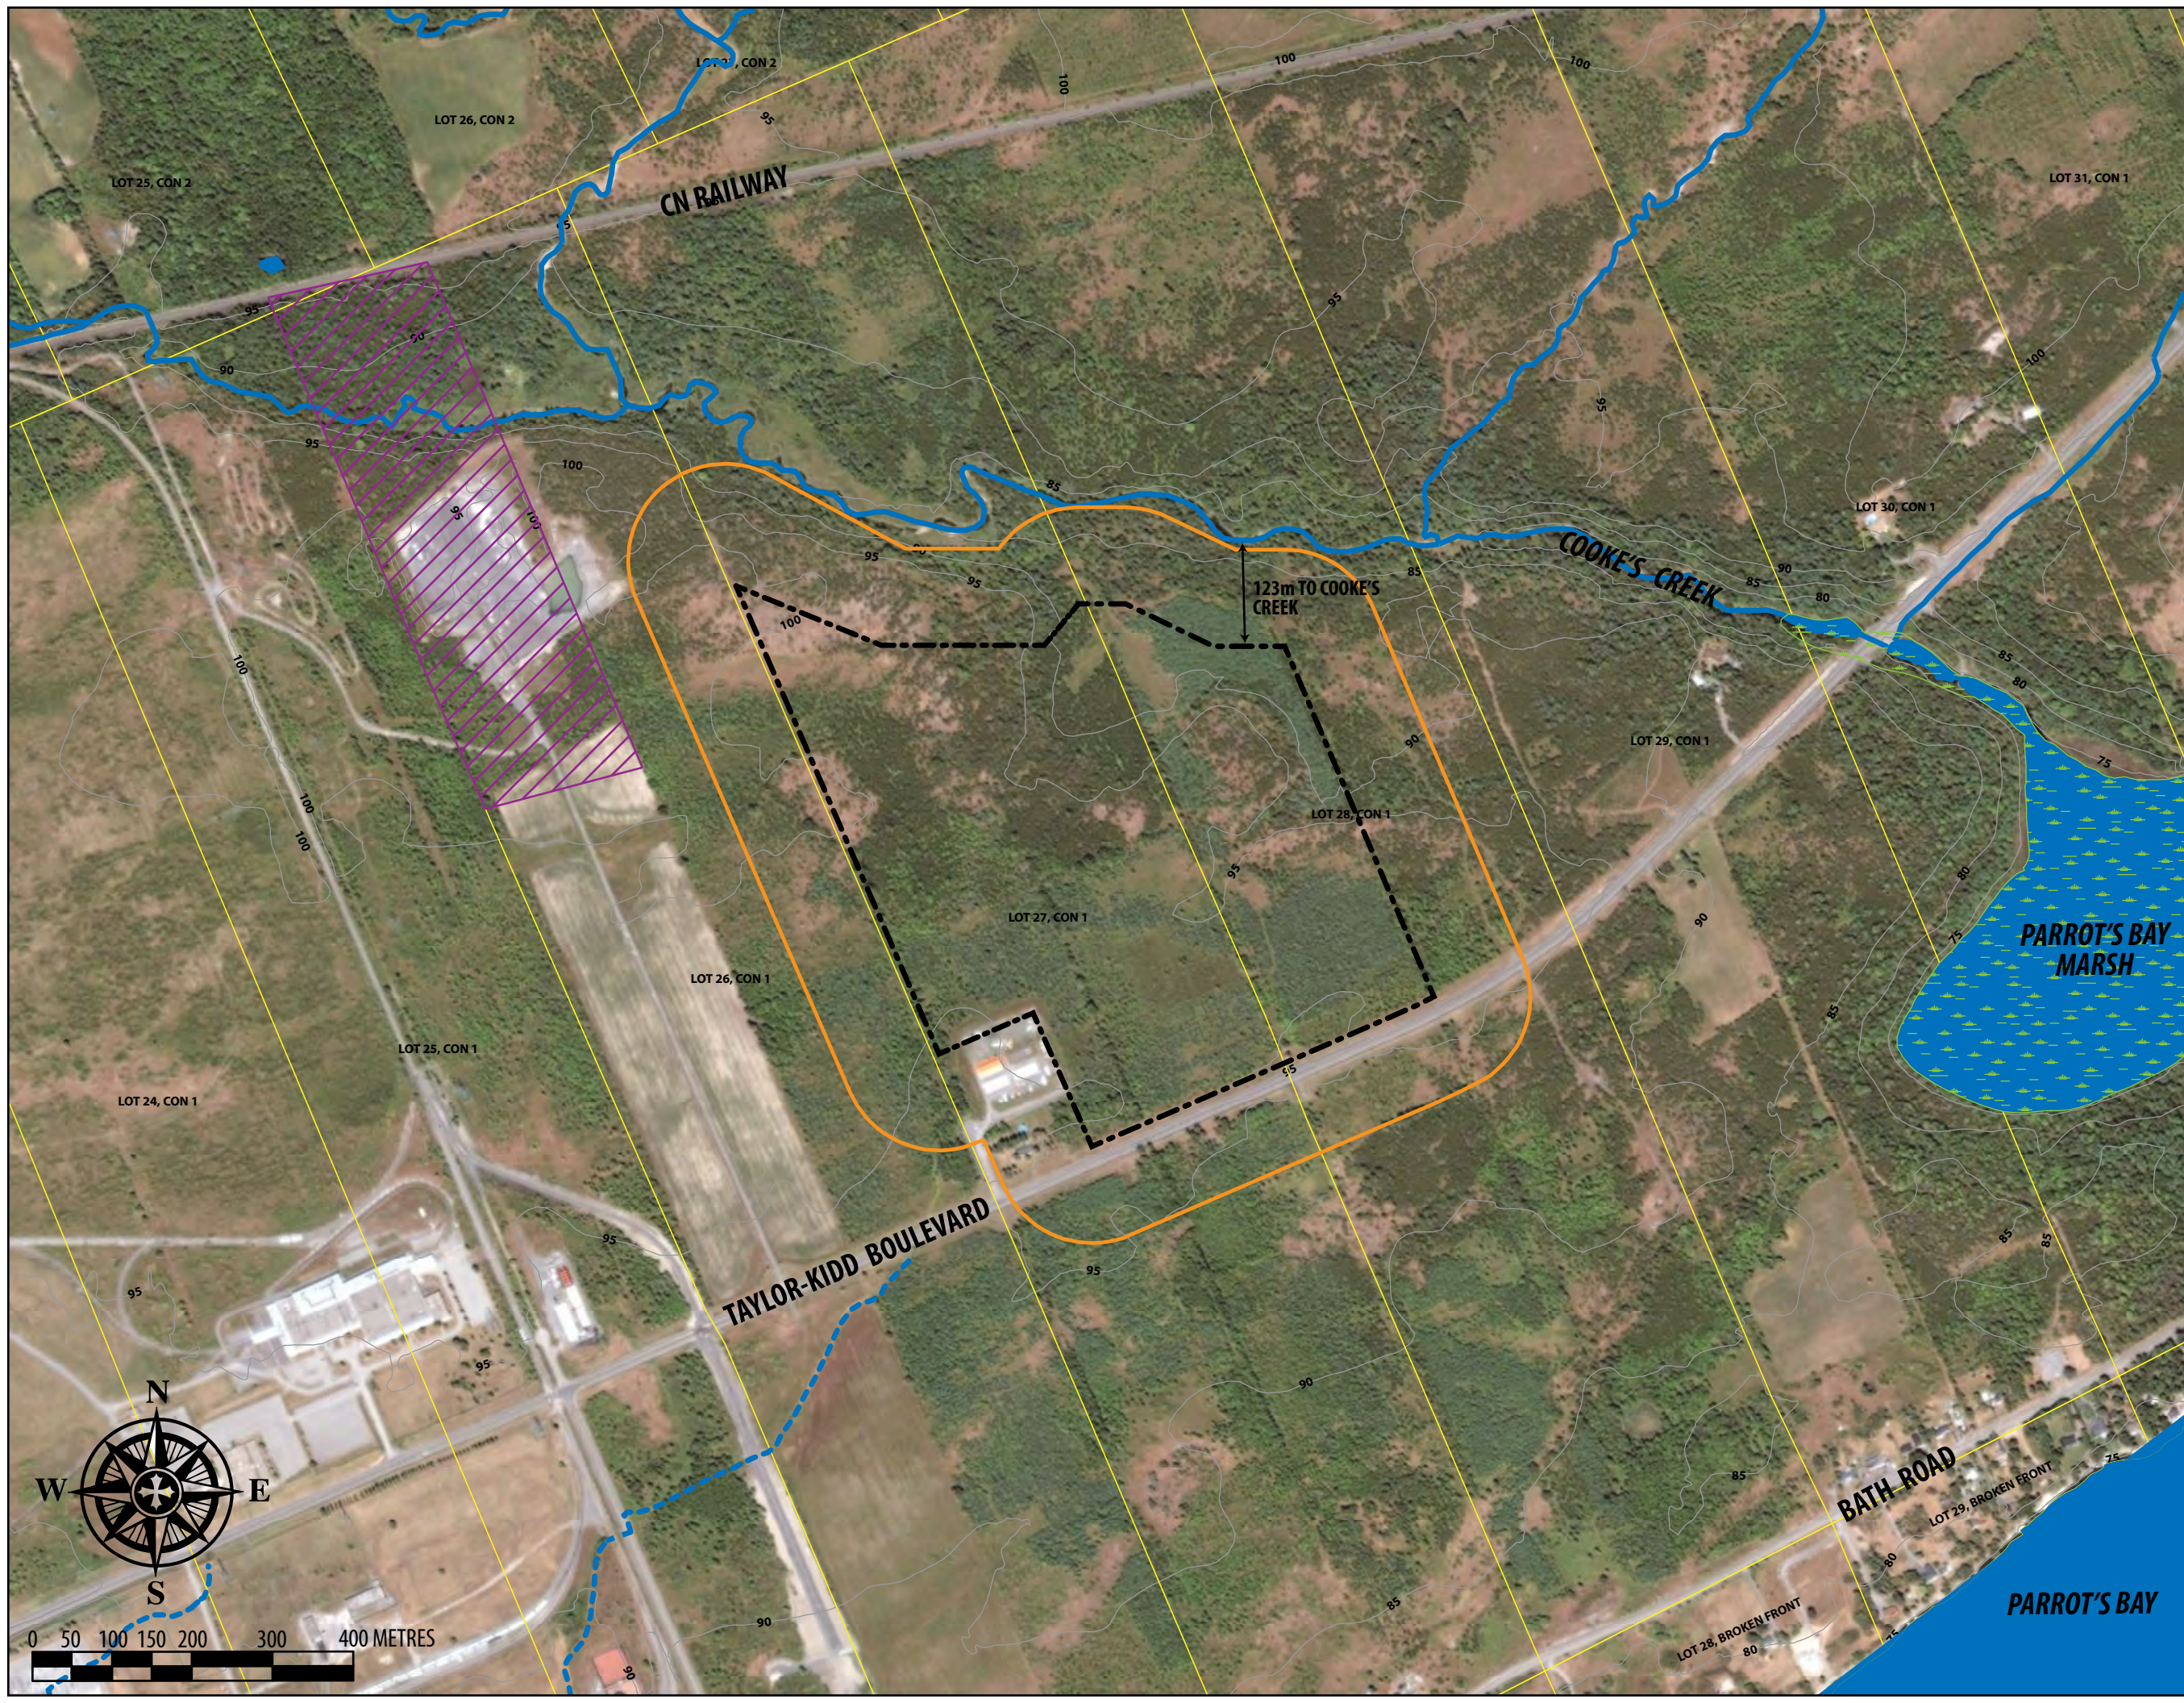
FIGURE 4.1

This section documents the results of the site investigations and discusses specific water body features observed on and within 120 m of the Project Location. Water body features that meet the definition of a water body according to the REA Regulation are shown on Figure 4.1. Other water features that were identified during the site investigations but don't meet the definition of a water body are also shown on Figure 4.1. The boundaries and distances of each water body feature (this excludes water features that do not meet the definition of a water body) confirmed during the site investigations are shown on Figure 4.1, including a 120 m setback from the Project Location, as per the requirements of subsection 31 (3) of the REA Regulation.

Surface run-off from the Project Location is ultimately conveyed north to Cooke's Creek or south across Taylor Kidd Blvd and eventually to Lake Ontario. There are no watercourses or water bodies present on or within 120 m of the Project Location. Cooke's Creek is located approx. 123 m to the north of the Project Location at its closest point.

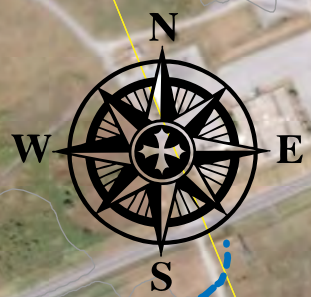
TITLE	NAPANEE TS TAYLOR-KIDD PROJECT BOUNDARIES AND WATER BODY SITE INVESTIGATION	
DATE	JULY 19, 2011	PROJECT No. KP-11-626
		FIGURE

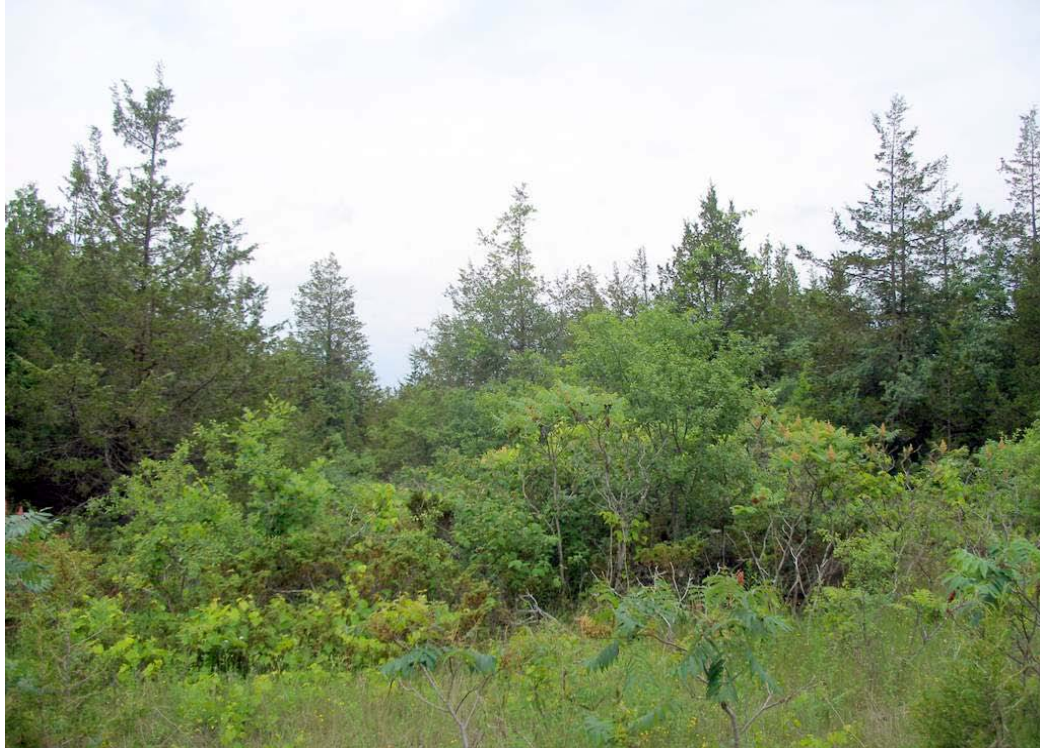
Figure 4.2 Typical thicket and red cedar woodland communities within Taylor Kidd Project Location.

The Project Location is situated north of Taylor Kidd Blvd in a rural area dominated by early-mid successional woodlands, conifer plantation and cultural thicket on abandoned agricultural lands (Figure 4.2). The City of Kingston is located approx. 15 km to the east.

The *Water Body Records Review Report* (Hatch Ltd., 2011) did not identify any permanent streams on or within 120 m of the Project Location. This was confirmed during a site investigation completed on June 17, 2010. Most of the site is represented by conifer plantation and red cedar dominated woodland (Figure 4.2). Cooke’s Creek, a permanent stream, is located approx. 123 m north of the Project Location at its closest point (Figure 4.3).
