**Water Body
Site Investigation Report**

**SunE Bruining
Solar Energy Project**

FIT Contract Number: FIT-FH7CNFM

prepared for
Genivar and SunEdison

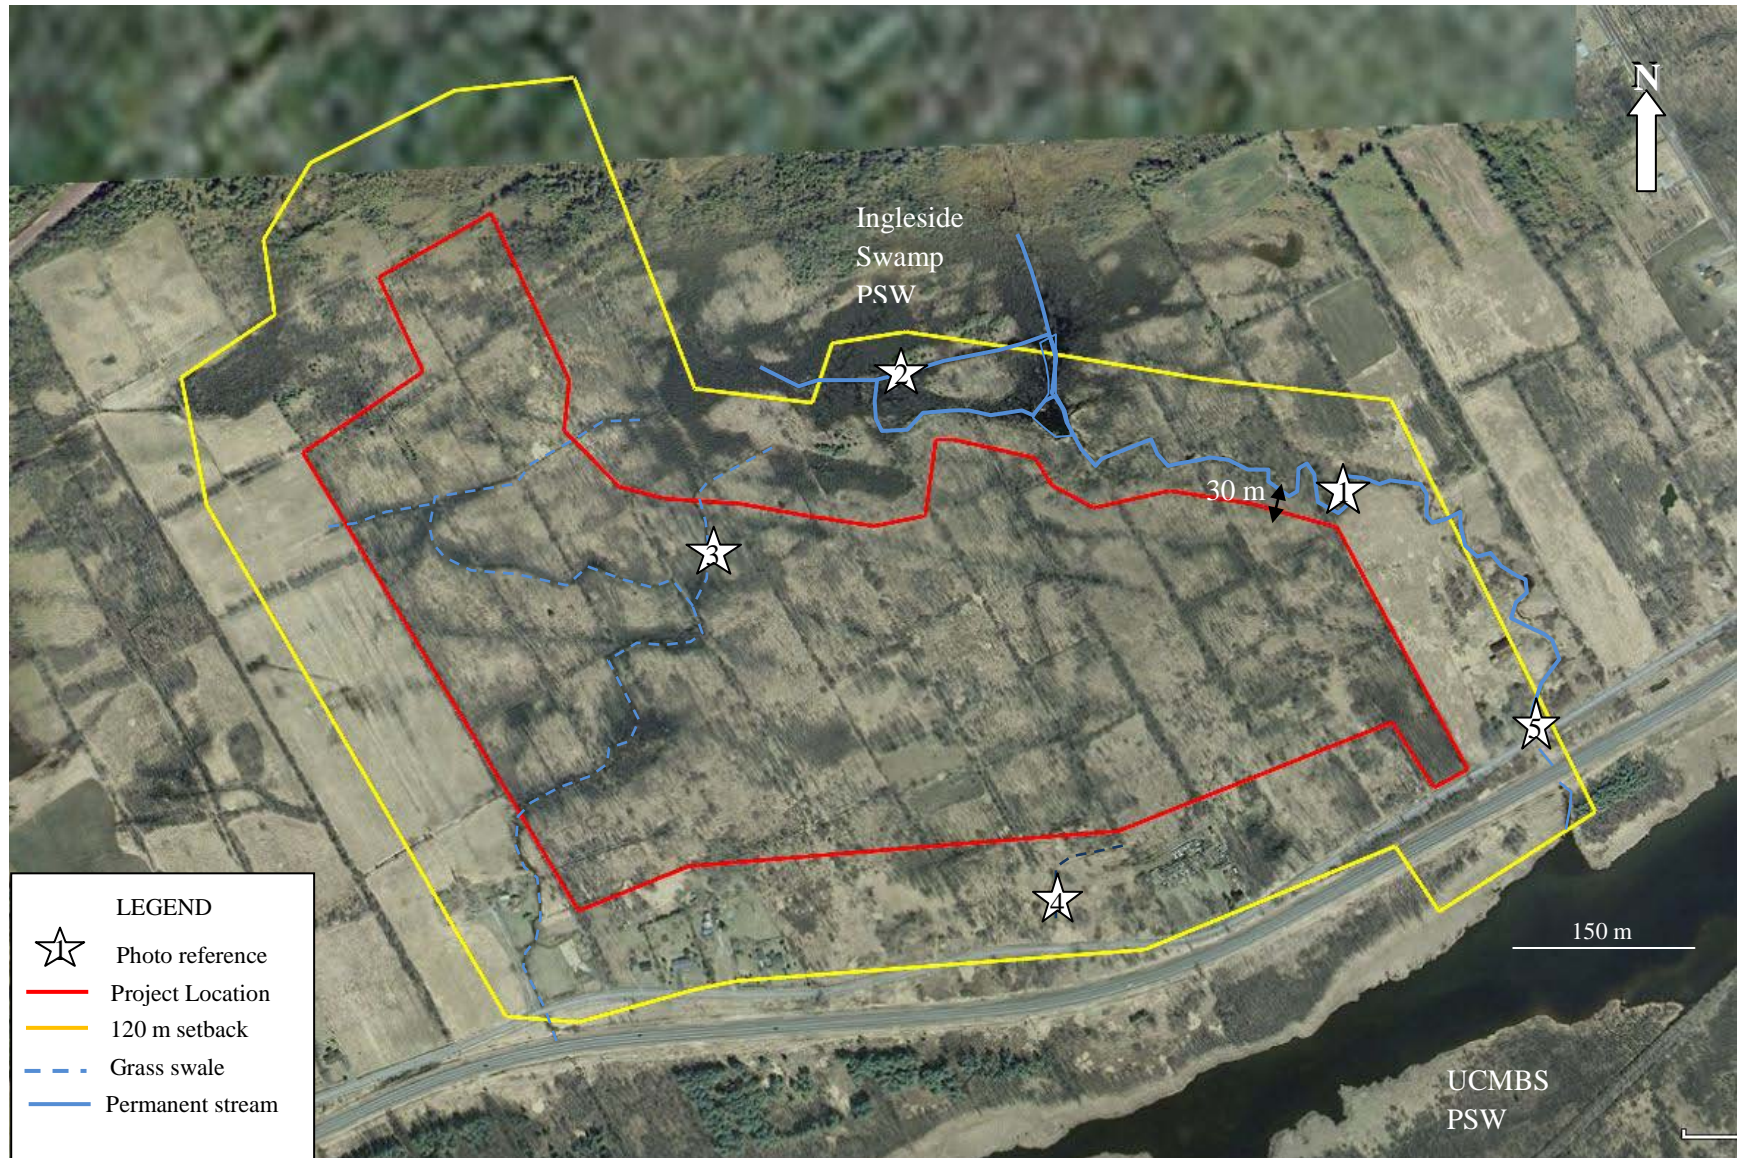
Figure 4.1 Water features within 120 m of the Bruining Solar Project Location.

The Project Location is situated north of Andersen Road/Highway 2, approx. 2 km west of the town of Ingleside in a rural area dominated by cropland and early-mid successional lowland forest and thicket. The Project is situated 120 m north of the St. Lawrence River within the St. Lawrence Lowlands Ecoregion. The site had been farmed prior to the 1960s, but was abandoned and allowed to succeed to deciduous woodland. However, as a result of recent logging activities by the landowner, the Project Location is now comprised mainly of dense shrubland with small remnants of former woodland. Two provincially significant wetlands occur within 120 m of the Project - to the north is Ingleside Swamp PSW and to the south is the UCMBS PSW. Agricultural lands and associated landowner dwellings occur to the east and west of the site (see Figure 4.1).

The Project Location is generally flat and occurs on poorly drained clay-loam soils. Surficial run-off across most of the site is conveyed south via a network of seasonally intermittent grass swales which also drain a small area of thicket swamp associated with the Ingleside Swamp PSW to the north. As small, seasonally intermittent features not dominated by aquatic or hydrophilic vegetation (Figure 4.2), they do not meet *O.Reg* 359/09 criteria for intermittent streams and will not be considered further in this report. Other portions of the Ingleside Swamp PSW to the north of the Project Location are drained via a series of excavated drainage channels that connect to a permanent creek that flows within the 120 m setback areas north and east of the Project Location eventually flowing south into a small embayment on the St. Lawrence River. These latter features meet *O.Reg* 359/09 criteria as a permanent stream (Figure 4.3).

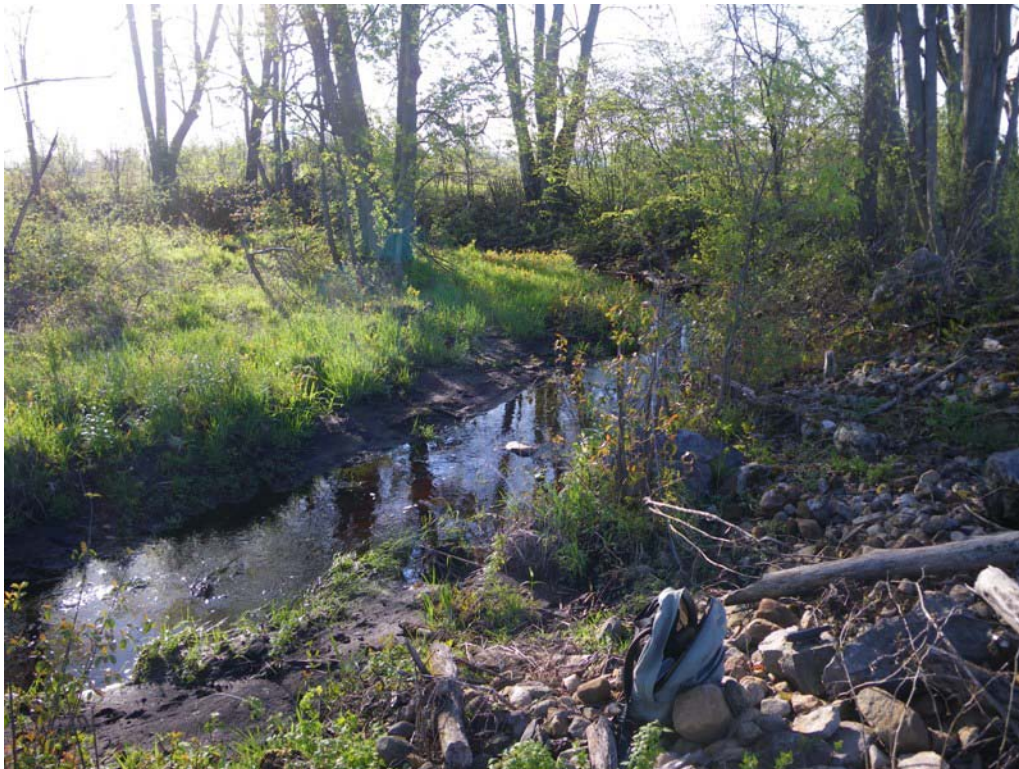
Figure 4.2 Permanent stream north and east of Project Location (Photo Ref 1)

The *Water Body Records Review Report* (Genivar, 2012) identified a permanent stream within 120 m of the Project Location (closest approach is 30 m). Characteristic stream features were recorded and photographed during site investigations in 2011 and 2012 (Figure 4.2). The stream originates approx. 1.5 km north of the Project Location within the Ingleside Swamp PSW and flows east and south across Anderson Rd and Highway 2 to a small embayment on the St. Lawrence River. The stream is associated with artificial drainage channels within the Ingleside Swamp PSW that were constructed as part of a wetland project managed by Ducks Unlimited. It is also connected to farm drains that have been recently cleaned and deepened by the landowner (Figure 4.3). Stream characteristics include:

Width (top of bank): 1 - 1.75 m

Depth at centre: 10 -20 cm

Flow: 0.25 m per sec in upper sections, reduced flow in lower sections

Substrate: Silt and clay, some organics at upper reach

Vegetation: No instream submergents or emergents, some riparian sedge, rush and willow communities

Other Instream Features: none noted, no pooling within 120 m of Project Location

Fish Habitat Potential: Some potential in lower reaches, but impediments to movement present

Erosion Potential: low to moderate (banks exposed as a result of recent drain clearing)

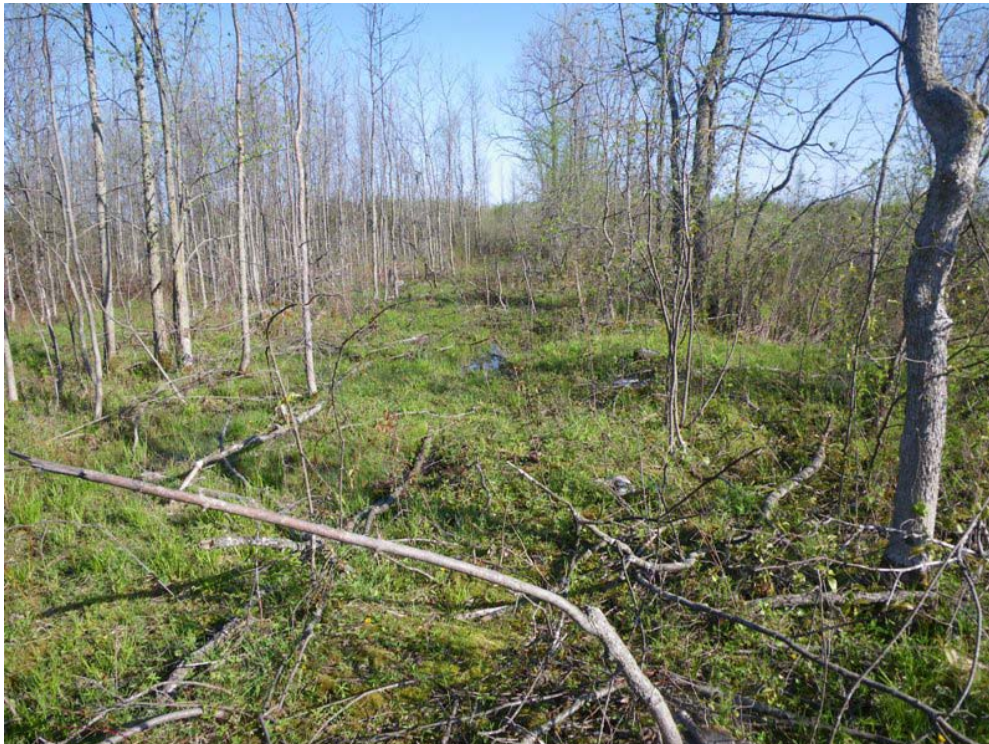
Figure 4.4 Grass swale drainage feature (Photo Ref 3).

Other water features that do not meet the definition of a water body as outlined in the REA Regulation were considered in this report for the Project Location and 120 m adjacent lands. Site investigations included observations of a network of grass swale drainage features (Figures 4.4 and 4.5) flowing across the Project Location south to a collector ditch along Anderson Road.

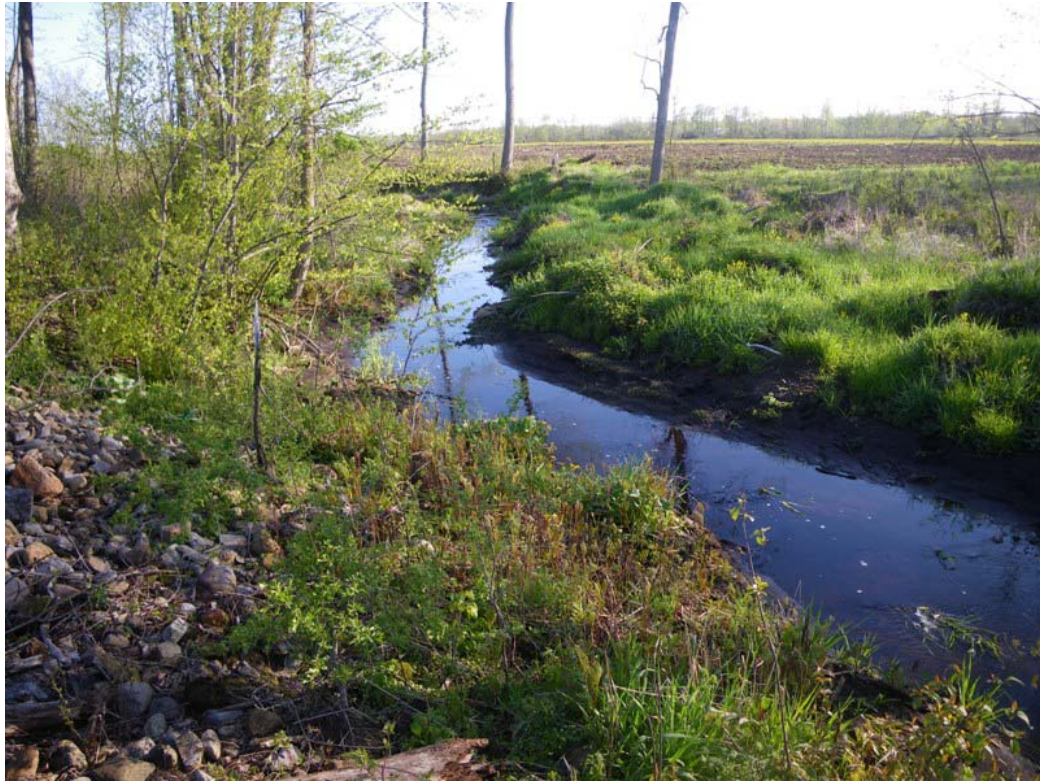
Cleared drain north of Project Location

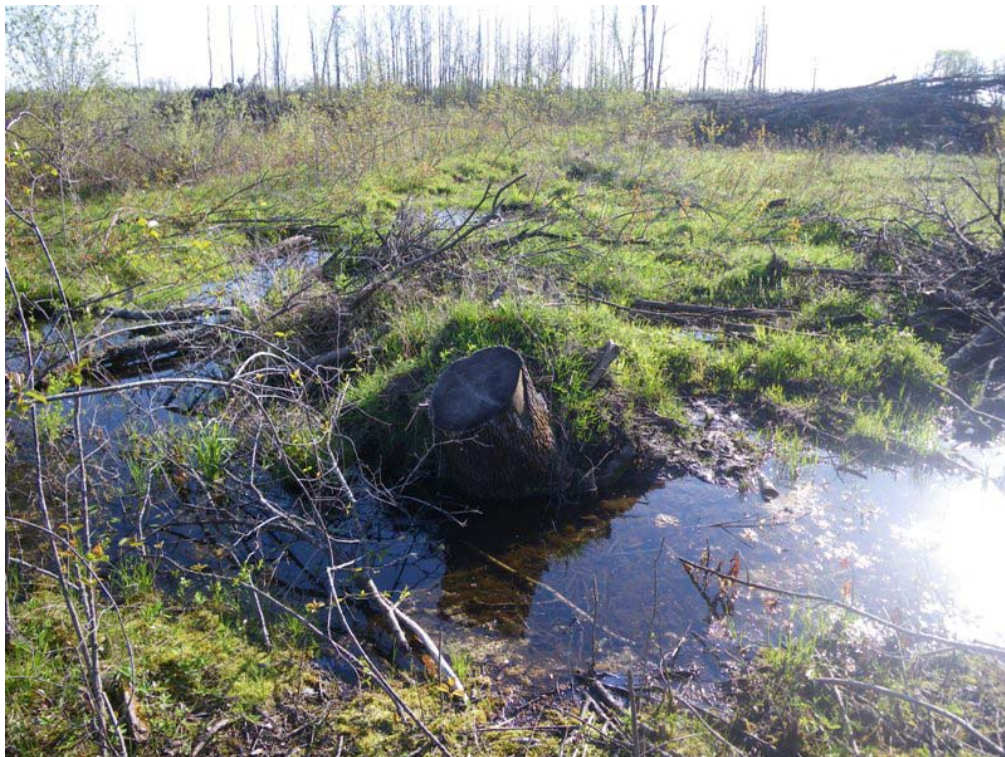
Stream overflow and clearing northeast of Project Location

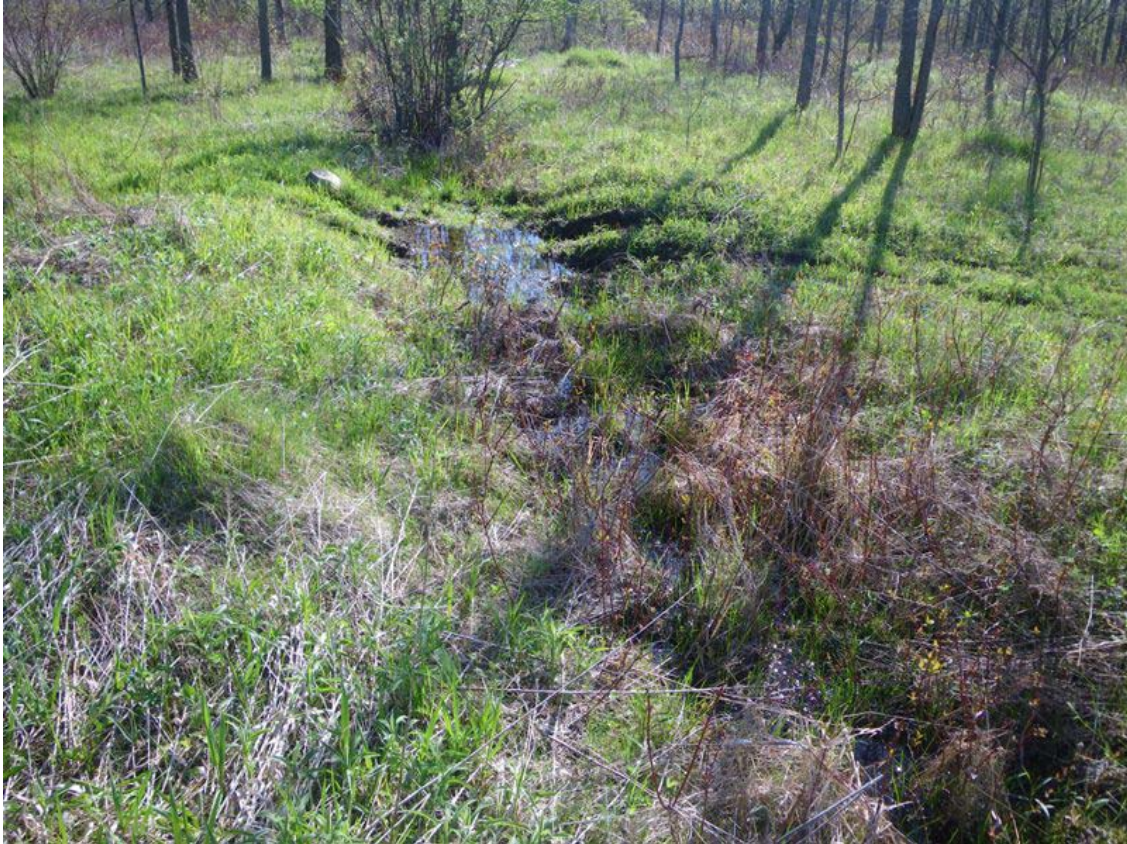
Grass swale and ATV tracks within Project Location
